Comparison of Standard Structural Mapping Results to 3-D Photogrammetric Model Results: Boundary Transformer Banks Rockfall Mitigation Project, Metaline Falls, Washington

Gates, W. C. B.

Haneberg, W. C.

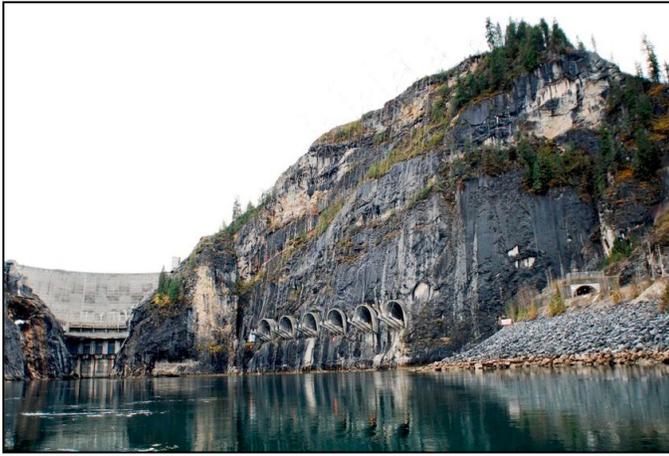
Fig. 1. Boundary Dam Hydroelectric Plant on the Pend Oreille River northeastern Washington, USA. Photo displays the northeast face above the transformer bays.

Seattle City Light (SCL) owns and operates the Boundary Dam and Hydroelectric Power Plant on the Pend Oreille River in the northeast corner of Washington State (Fig. 1) [1]. SCL began producing electricity with one generator in 1967 and now produces over 25% of Seattle's electricity. Presently there are six hydro-generating units all housed in a large machine room within the dolomitic rock massif. The units are coupled with individual step-up transformers in rock bays, at the bottom of a 150 m high cliff above the tailrace. Transmission lines exit the transformer bays horizontally on outriggers, and then run vertically up the face to stand-off structures referred to as "pickleforks" atop the rock massif. From there, the lines tie into the Northwest Power Grid.

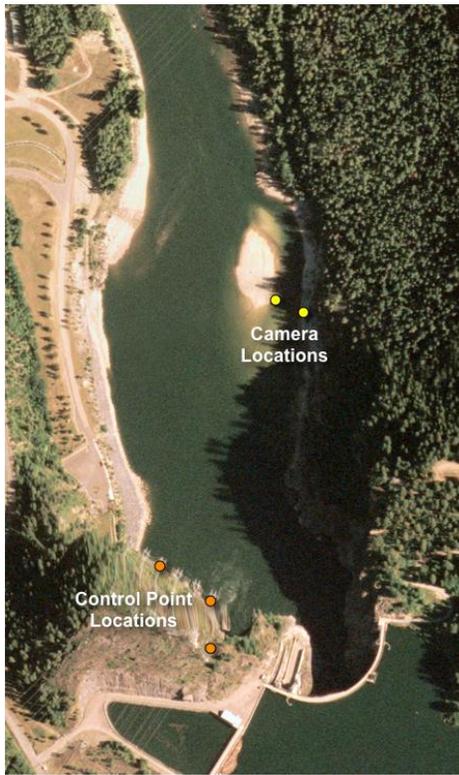
Fig. 2. Orthophoto showing Boundary Dam and its forebay, the Pend Oreille River, the dolomite massif, and the camera locations and control points used for photogrammetric modeling. North is towards the top of the photograph.

In preparation for mapping the northeast face of the rock massif, photographs were taken mid-day on March 2, 2010, with a tripod mounted Nikon D200 (10 megapixels) and a Nikkor 24 mm f/2.8 D lens. Overcast skies produced relatively even and diffuse light during the time the photographs were being taken, although the north facing rock slope was shadowed because of its orientation, time of year, and latitude of the dam. Three control points consisting of bright orange military signal panels, each marked with a large white "X", were temporarily hung on the rock face by the authors. The control points and camera locations were surveyed and delivered on-site for immediate use. Fig. 2 displays the locations of the control points and the camera.
