## Terrestrial photogrammetry and LiDAR investigation of the cliffs associated with the seismically triggered rockfalls during the February and June 2011 Christchurch earthquakes

**ABSTRACT:** The February 22 and June 13, 2011 Christchurch earthquakes (Mw 6.2 and 6.0 respectively), on the South Island of New Zealand, triggered widespread rockfall activity in the Port Hills area. Due to the epicentre locations, large amount of energy released, and the steep topography; Peak Ground Accelerations (PGA) of 2.2 g were recorded in the hills south east of Christchurch. The local bedrock geology consists of Miocene basaltic lava flows with interbeds of breccia and tuff. Terrestrial photogrammetry and laser scanning techniques were used to characterize the rock masses in cliffs at three fieldsites that experience rockfall activity. The advantages and limitations of each technique are discussed in terms of the discontinuity pattern mapped, and orientation biases.

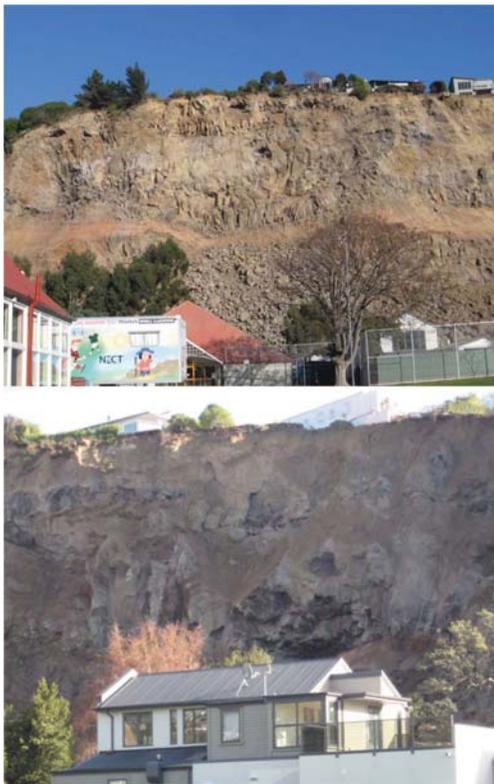
Figure 3. Overview of the a) western and b) northern wall at the Redcliffs school field site.

This paper will concentrate on three sites in the Port Hills area that are abandoned sea cliffs (Fig. 2). The first site is the Redcliffs School (Fig. 3), the second is Peacock's Gallop (Fig. 4), and the third is Wakefield Terrace (Fig. 5) in the locality of Sumner.

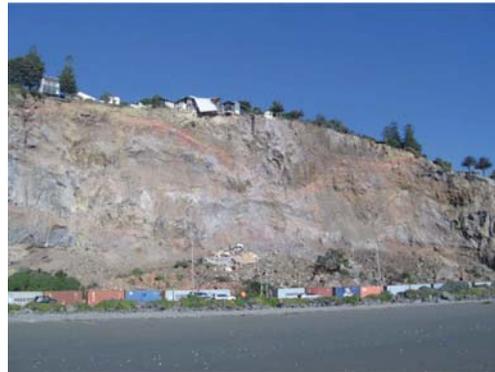
Figure 4. Overview of the Peacock's Gallop field site. Note the paleochannel in the central upper part of the cliff and the use of shipping containers as rockfall barrier.

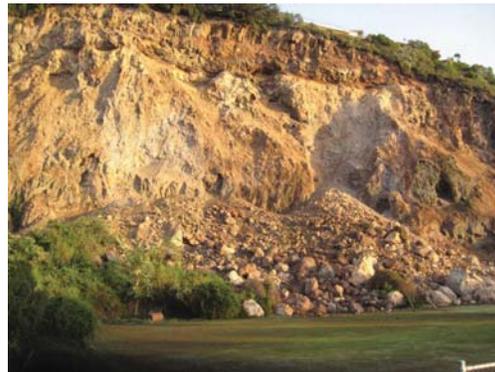
Figure 5. Overview of the geology and rockfall talus at the Wakefield Terrace field site.

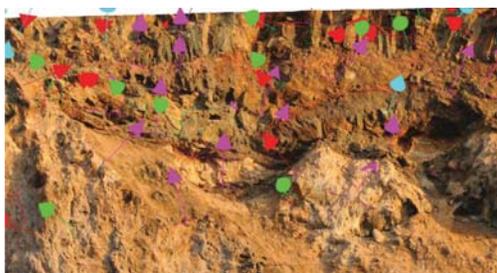
Figure 6. Example of the 3D model created based on the terrestrial photogrammetry for the Wakefield Terrace fieldsite.

Terrestrial photogrammetry was the primary method used in this study to collect discontinuity orientation and characteristics data. Sturzenegger & Stead (2009a, b) have demonstrated its applicability to assess the orientation of discontinuities in large natural rock slopes and open pits. The digital imagery analysed in this project was acquired using a Nikon 300s digital

camera with 50 mm and 105 mm focal length lenses. The images obtained were processed using the software Siro3D and SiroJoint (CSIRO 2010). The position of the camera was determined in the field using a real time kinematic global positioning system (RTK GPS) which along with the bearing of the line of sight of the camera was used to geo-reference the 3D models created using the Siro3D software. The orientation and persistence was extracted from the 3D models by defining a plane or trace corresponding to a discontinuity in SiroJoint (Fig. 6). These software have previously been used successfully to collect orientation data in large road cuts in the United States (Haneberg 2008) and coal mines in Australia (Maconochie et al. 2010).

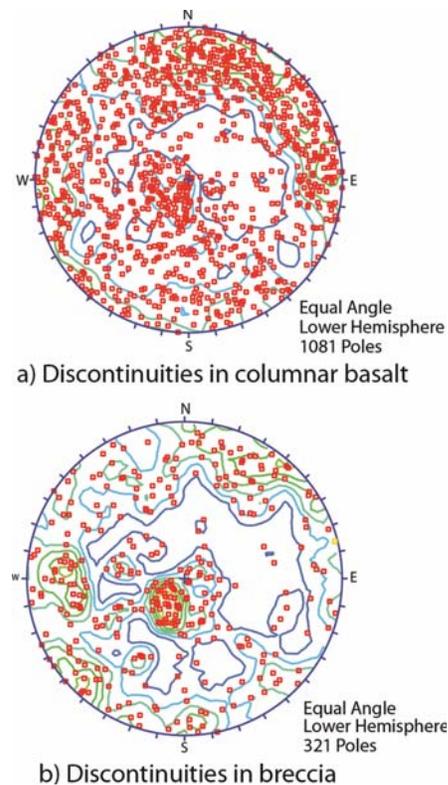
Figure 10. Cumulative stereographic projection of the poles to the discontinuity identified using terrestrial photogrammetry at all three fieldsites as a function of the geology a) columnar basalt and b) breccia, pyroclastic and tephra.

Approximately 75% of the discontinuity planes or traces identified in the photogrammetry were from the columnar basalt geological unit. To assess the importance of this sampling bias Figure 10 compares the stereonets of the poles to the discontinuities obtained from the columnar basalt and breccia (including pyroclastics and tephra) units. There does not appear to be significant differences in the discontinuity pattern between the different geological units. The thinner depositional thicknesses of columnar basalt unit led to
